### Pampanga Delta Development Project, Flood Control Component (1)

External Evaluator: Taro Tsubugo

Field Survey: November 2004

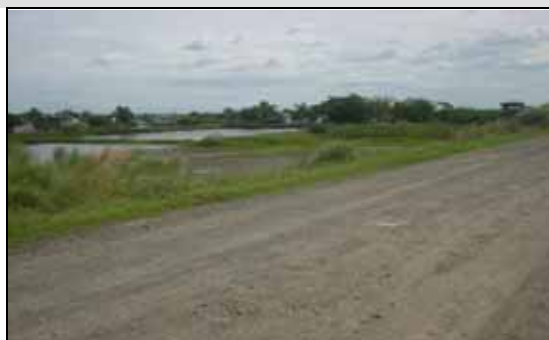
A newly-developed dike road

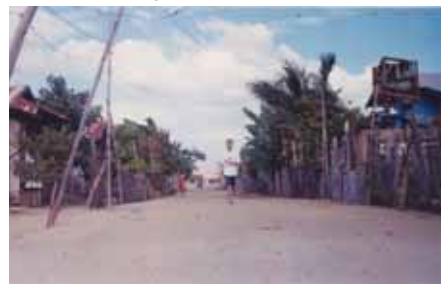
Fig. 2. Base Mound

<sup>2</sup> An area of 60.6 hectares encompassing 14 sites and 2,614 households was prepared along both sides of the dike in the lower basins of the Pampanga Delta (Base Mound).

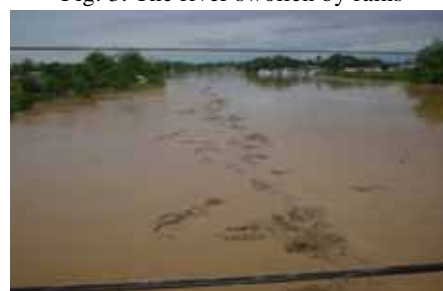
Fig. 3. The river swollen by rains

On the left bank, inundation in the area without new dikes (Candelaria and Calumpit) causes flooding. This type of flooding results in the inundation of flood waters into the beneficiary area, which occurs at least once a year. On the right bank, backwater from the Pampanga River causes runoff problems in northern parts of the beneficiary area<sup>4</sup> and, eventually, flooding damages. Backwater occurs when water levels in the Pampanga River and its tributary are high. In addition, the eruption of Mt. Pinatubo in 1992 heightened riverbeds in adjacent branches of the river<sup>5</sup> and prevents smooth drainage.

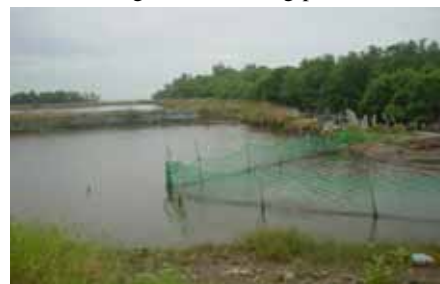
Fig. 5. A breeding pond

In the beneficiary survey to residents who are engaged in the farming and fishing activities (50 from aquaculture; 8 from agriculture), 66% of those engaged in aquaculture cited an increase over pre-project levels, with 24% attributing this to the PDDP. It is believed that less frequent flooding and a

reduction in the extent of damages have increased the number of annual productions and diminished the risks involved in undertaking aquaculture. In addition, approximately half of those engaged in aquaculture (47%) pointed to higher profit margins and more favorable environmental conditions, which are enabling them to pursue production activities throughout the year.
